**Flood Control Project Maintenance
Levee Inspections**

Maintenance Issue Types Only, Levee Inspection Report By Mile - Fall 2016

Reclamation District No. 0070 Meridian

Waterway	Bank	Unit Miles	Inspection Start/End	Inspector
Unit No. 01 Sutter Bypass	Right	7.92	10/18/2016 10/18/2016	Tariq Chechi

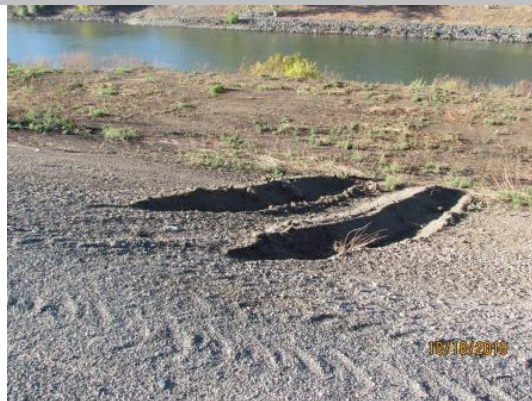
Photo 1 of 1 : FA_2016_RD0070_30_48_20161028_00107.jpg

LM Start	1.40	Rating **	M	Issue No.	48							
LM End	1.40	Issue Type +	Ma	Location *	WS							
Category	Earthen Levee		GPS Latitude/Longitude									
			Start	End								
Item	Slope Stability		39.178369 °	39.178369 °								
			-121.942657 °	-121.942657 °								
DWR ID	DWR_RD0070_02_f_2016_48											
Comment Code												
S3 : Repair the levee slope damaged by vehicle traffic and prevent access where possible.												
Inspector Comment

View of the ruts along the waterside slope.

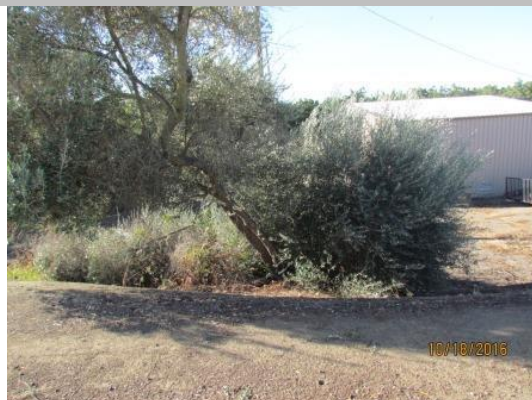
Photo 1 of 1 : FA_2016_RD0070_30_54_20161028_00110.jpg

LM Start	4.95	Rating **	M	Issue No.	54
LM End	4.95	Issue Type +	Ma	Location *	LS
Category	Earthen Levee			GPS Latitude/Longitude	
				Start	End
Item	Trim / Thin Trees			39.142016 °	39.142016 °
				-121.926214 °	-121.926214 °
DWR ID	DWR_RD0070_02_f_2016_54				
Comment Code					
T1 : Trim trees to at least five feet above ground level.					
Inspector Comment

View of the trees blocking visibility.

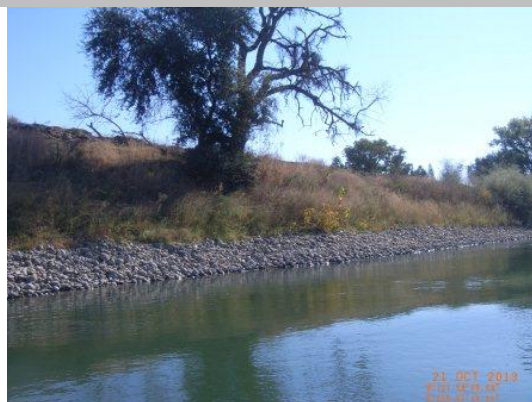
Photo 1 of 1 : FA_2016_RD0070_30_2_20160823_00002.jpg

LM Start	8.10	Rating **	M	Issue No.	2
LM End	8.23	Issue Type +	Ma	Location *	WS
Category	Supplemental			GPS Latitude/Longitude	
				Start	End
Item	2015 USACE Erosion Survey, DRAFT			39.122459 °	39.120684 °
				-121.910121 °	-121.909152 °
DWR ID	DWR_RD0070_02_s_2016_2				
Comment Code					
Inspector Comment					
1997 - Critical Site - Erosion of cobble site on outside of a bend. Failure caused by erosion of a material from behind the cobbles and cobbles rolling down the slope. Failure is just above the toe levee. Some repairs had been done at the upstream end. 2004 - Some minor new erosion at the top of the berm. 2005 - Trees look okay and the downstream end has some new rock repair. Site is no longer critical. 2006 - No longer critical, some repairs. 2015: No observed changes. [2015 Site ID: SAC_130-0_L]

USACE 2013 Photo #1

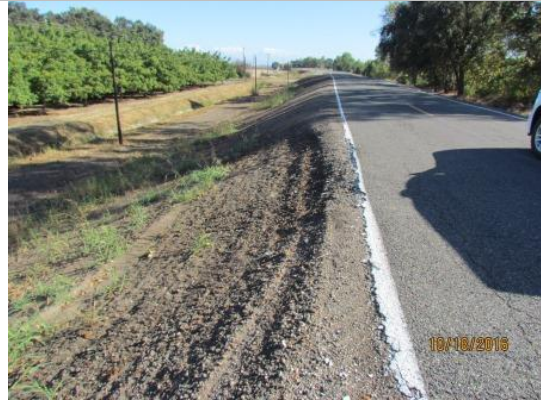
Photo 1 of 1 : FA_2016_RD0070_30_66_20161028_00118.jpg

LM Start	14.14	Rating **	M	Issue No.	66
LM End	14.14	Issue Type +	Ma	Location *	LS
Category	Earthen Levee			GPS Latitude/Longitude	
				Start	End
Item	Slope Stability			39.069849 °	39.069849 °
				-121.857267 °	-121.857267 °
DWR ID	DWR_RD0070_02_f _ 2016_66				
Comment Code					
S1 : Repair slope instability.					
Inspector Comment

View of slope instability along the landside slope.
